# Recognition of materials and damage on historical buildings using digital image classification

Our case study applies to the Santa Marina de Aguas Santas Church in Córdoba (Spain). This church is a historical building dating back to the 13th century and is of great cultural heritage value. The monitoring of its conservation state is thus necessary.

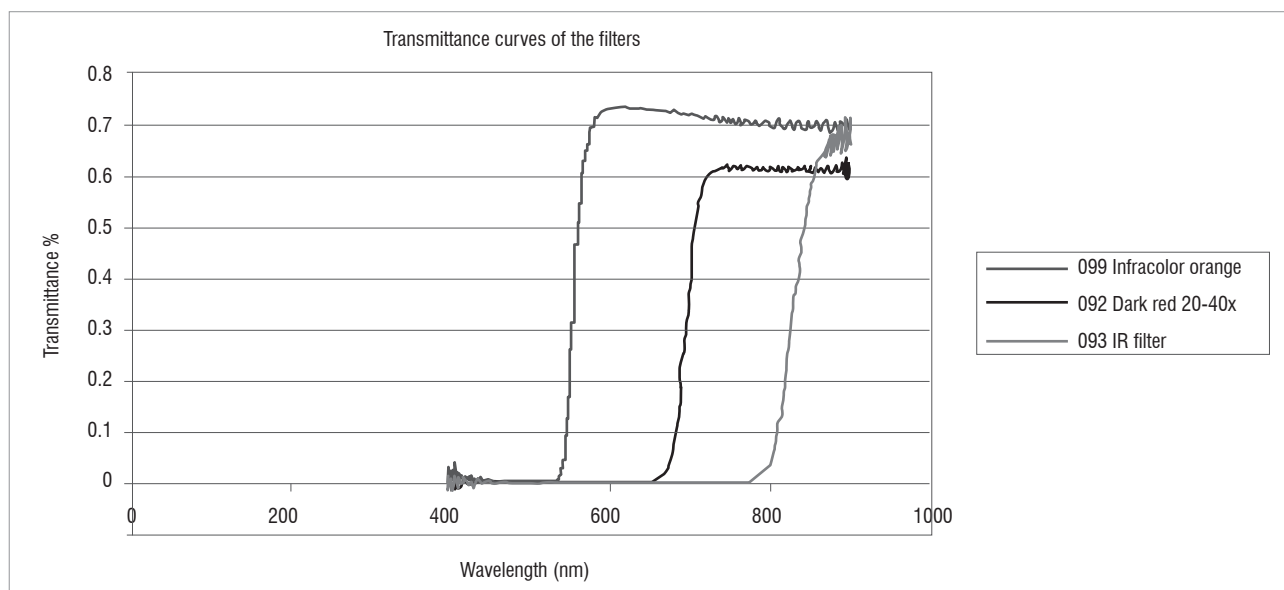
Figure 1 shows that the filter absorbs almost all light until a wavelength of approximately 550 nm and consequently filters all the spectral information corresponding to ultraviolet and the visible portion composed of blue and green. Part of red is also reflected; hence, the light passing through the filter will be formed by infrared and the orange area.

Figure 1: Transmittance curves of the B+W 099, 093 and 092 filters.

The choice of the filters to use in this study was based on previous results obtained by the working group.<sup>28</sup> These filters, whose transmittance curves are shown in Figure 1, were characterised using a calibration sphere Li-Cor 1800-12.<sup>29</sup> The filters were obtained from B+W (Berlin, Germany).

This filter has a transmittance curve characterised by an inflection point in the wavelength region of 690 nm. This curve indicates that the filter eliminates the ultraviolet response and practically the entire visible portion, except for dark red. As a result, the light beam will be characterised by an infrared and partly dark red spectrum.

This filter eliminates ultraviolet and the entire visible portion as it screens the beam of light up to the area close to 830 nm, which is already in near infrared.

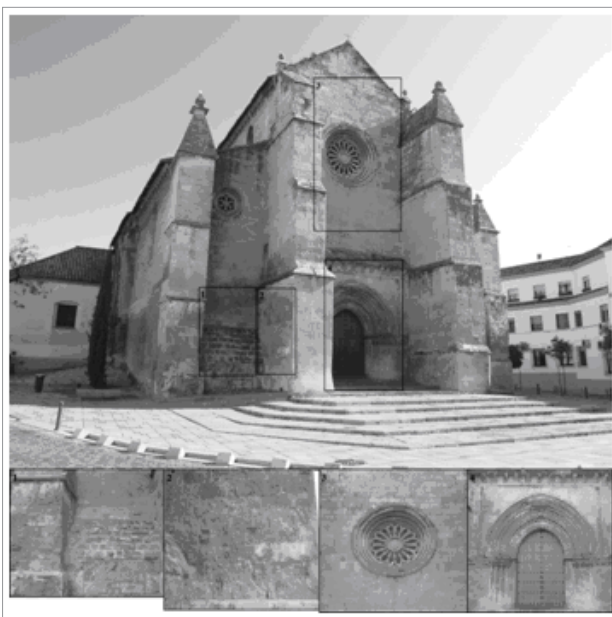
Figure 2 shows the four study areas selected for the characterisation of the materials and their alterations. These areas have important damage and they need to be restored. Four false colour photographs were taken of each area, using the camera with: (1) no filters, (2) a B+W 099 filter, (3) a B+W 092 filter and (4) a B+W 093 filter.

**Figure 2:** The Santa Marina Church, Córdoba. Insets: Areas of the building that were studied.

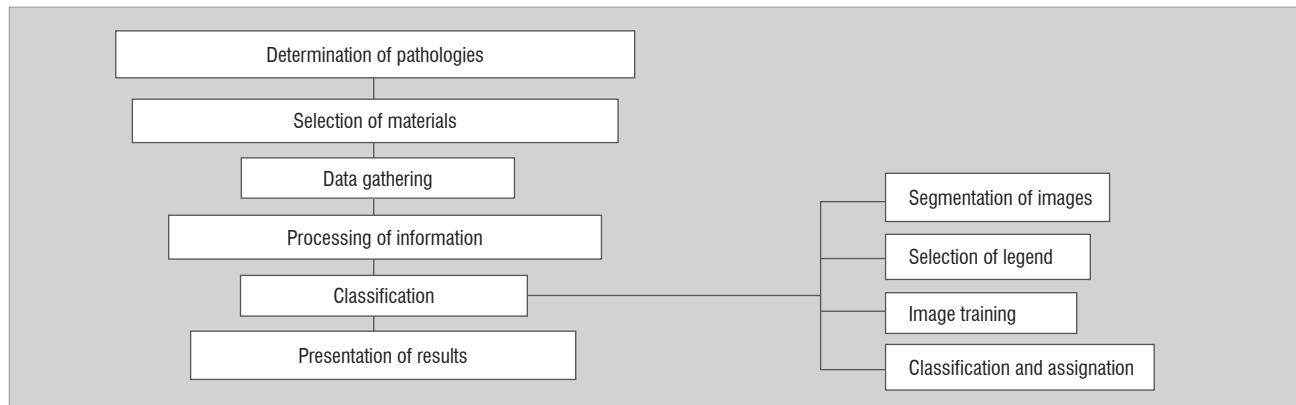
Figure 4 shows a diagram of the methodology followed in this study to identify the pathologies from the classification of hyperspectral images taken. The object-oriented classification technique applied is described below.

Figure 4: Phases for the identification of stone pathologies.

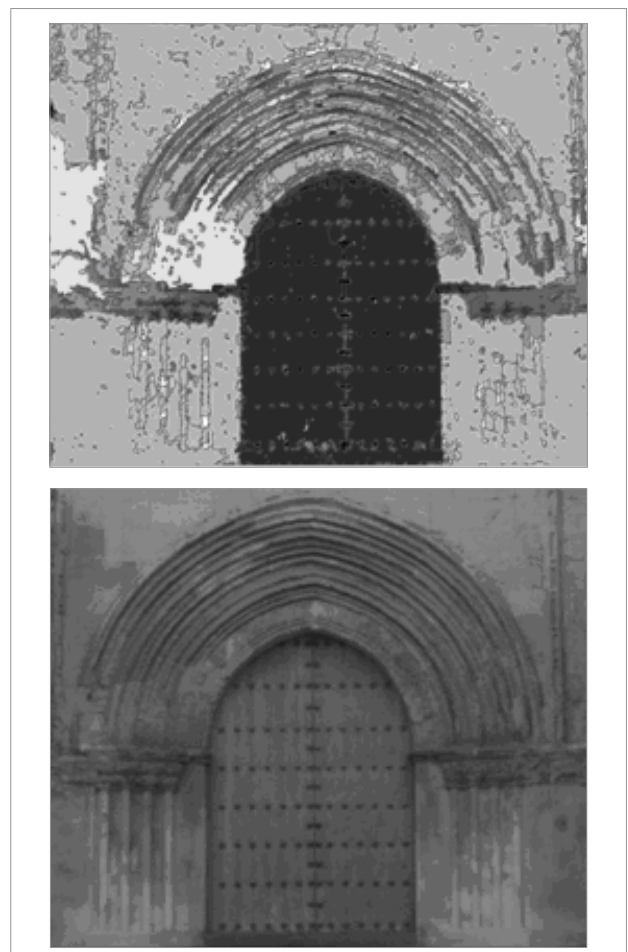
Figure 5: Comparison between the segmented composition (upper) and the original composition (lower) of the main door of the Santa Marina Church, Córdoba.

Image segmentation requires the performance of numerous tests to obtain a result that provides the best fit with reality. To obtain adequate results, various segmentation tests were carried out on each wall analysed using different configuration parameters until the appropriate segmentation was found. Figure 5 shows a good segmentation of the main door of the Santa Marina Church. The settings chosen for each wall are outlined in Table 1.

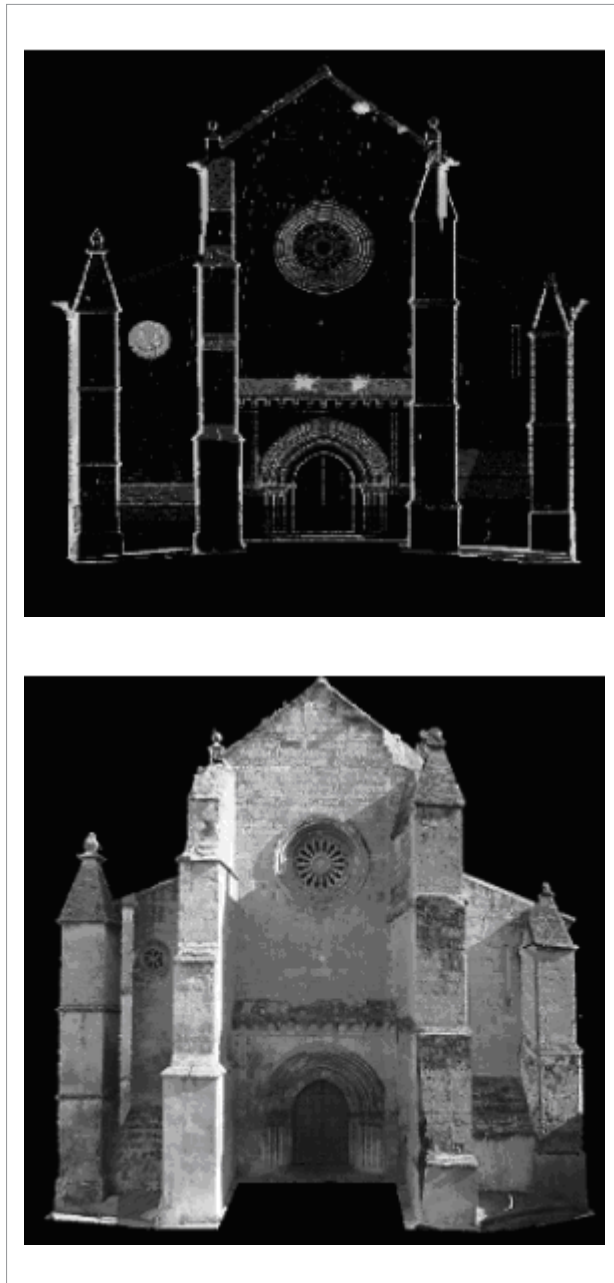
Figure 6 shows an orthophotograph of the façade based on a real colour photograph. This photograph was a high-resolution orthophotograph (3735 x 2610 pixels) in which measurements and annotations could be made, showing the three-dimensional structure of the morphological details found on the façade of the building.

Figure 6: Virtual model of the façade (upper) and orthophotograph of the façade (lower) of the Santa Marina Church.

Figure 5 shows a virtual model of the principal façade.

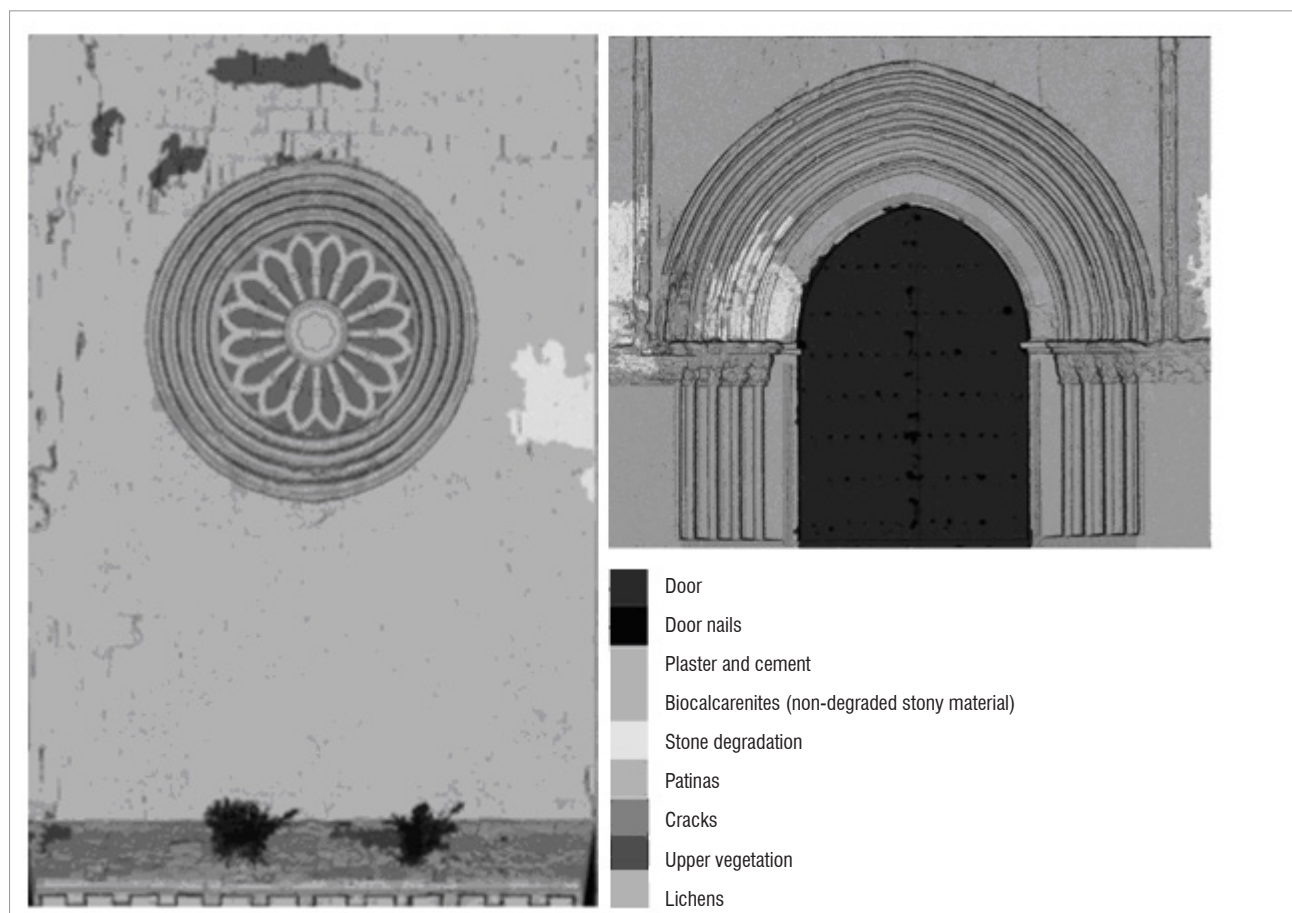
Finally, the corresponding orthophotographs were obtained based on the classified images and using the three-dimensional model of the façade obtained with the terrestrial LiDAR. These orthophotographs already had metric characteristics in which measurements could be taken, allowing the exact position of the detected pathologies to be determined and the exact surface area affected by these pathologies to be quantified (Figure 7).

Figure 7: Object-oriented classifications of the rosette (left) and of the main door (right) of the Santa Marina Church.
